**Flood Control Project Maintenance
Levee Inspections**

Maintenance Issue Types Only, Levee Inspection Report By Mile - Fall 2014

Reclamation District No. 0787 Fair

Waterway	Bank	Unit Miles	Inspection Start/End	Inspector
Unit No. 01 Colusa Basin Drain	Left	4.45	10/17/2014 10/17/2014	Clay Thomas

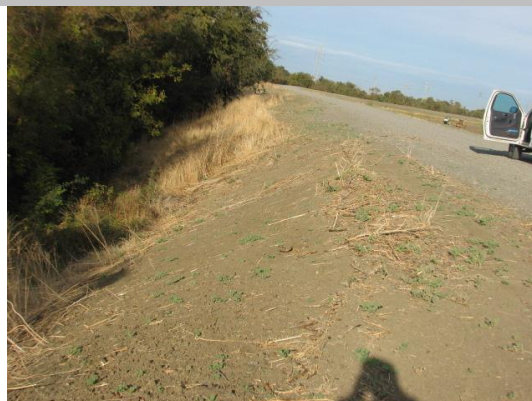
Photo 1 of 1 : FA_2014_RD0787_212_6_20141106_00010.jpg

LM Start	0.00	Rating **	A	Issue No.	6	
LM End	4.40	Issue Type +	Ma	Location *	WS	
Category	Earthen Levee			GPS Latitude/Longitude		
				Start		End
Item	Vegetation					°
						°
DWR ID	DWR_RD0787_01_f_2014_6					
Action/Comments						
Control annual grass and weeds on the levee slopes and easements.

This is the water side levee slope, vegetation exist beyond 20 feet of the crown but does not block visibility. Fall 2014. Levee mile 0.78.

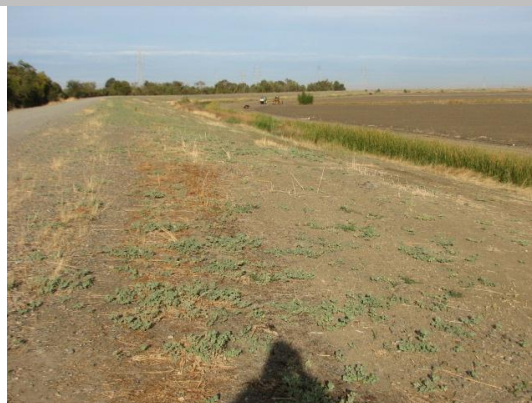
Photo 1 of 1 : FA_2014_RD0787_212_9_20141106_00011.jpg

LM Start	0.00	Rating **	A	Issue No.	9
LM End	4.40	Issue Type +	Ma	Location *	LS
Category	Earthen Levee			GPS Latitude/Longitude	
				Start	End
Item	Vegetation				°
					°
DWR ID	DWR_RD0787_01_f_2014_9				
Action/Comments					
Control annual grass and weeds on the levee slopes and easements.

Levee mile 0.78, land side vegetation. Fall 2014.
